Primary Name	Location Address	City	County	Postal Code
DALTON CORPORATION WARSAW MANUFACTURING FACILITY	1900 E JEFFERSON ST	WARSAW	KOSCIUSKO	46580

Re: Violation Letter  
Dalton Corporation/Warsaw  
IND 005 146-022  
Warsaw, Kosciusko County

Type of Inspection:	<u>X</u>	Compliance Evaluation Inspection
	<u>    </u>	Complaint
	<u>X</u>	Other: <u>Restricted Waste Site Inspection</u>
Results of Inspection:	<u>    </u>	No violations were observed
	<u>    </u>	Additional information and review is required to evaluate overall compliance.
	<u>X</u>	Violations were observed and will be referred to the Office of Enforcement. See inspection report.

The restricted waste site is permitted as a Type II landfill for the disposal of wastes generated by Dalton's foundry operations. The total acreage of the facility is 156 acres with 68.4 acres permitted as a Type II landfill. The facility is currently filling in all three Phases and has not minimized the working face of the landfill. Intermediate cover has only been applied to the western edge of Phase 1 and the southern edge of Phase 2. There are many areas that have not received waste within one year and have not received intermediate cover. Cu

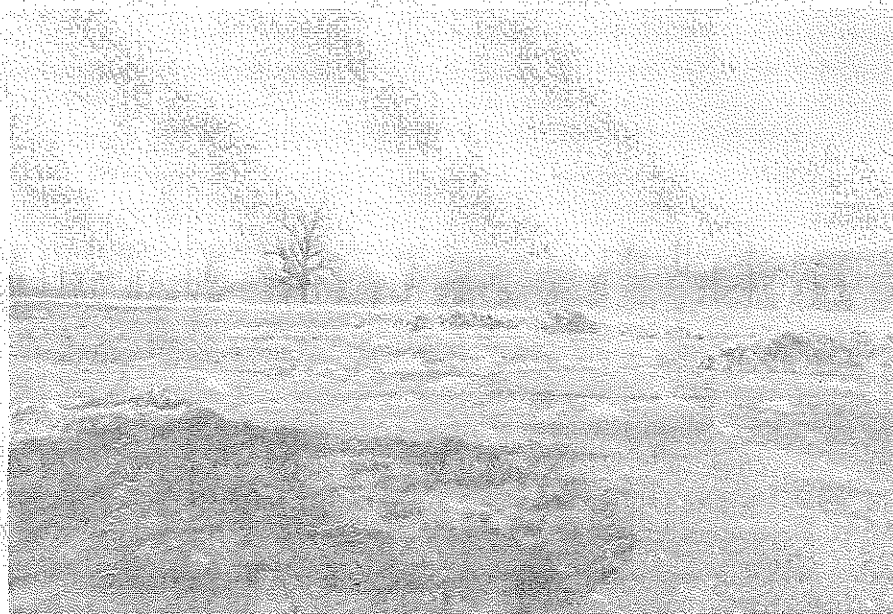
**Photo 1**

**Location and Subject:** East side of Phase 1, facing west – Exposed area of Phase 1 where runoff migrates to the drainage ditch north of the landfill and then to the outfall at State Road 25.

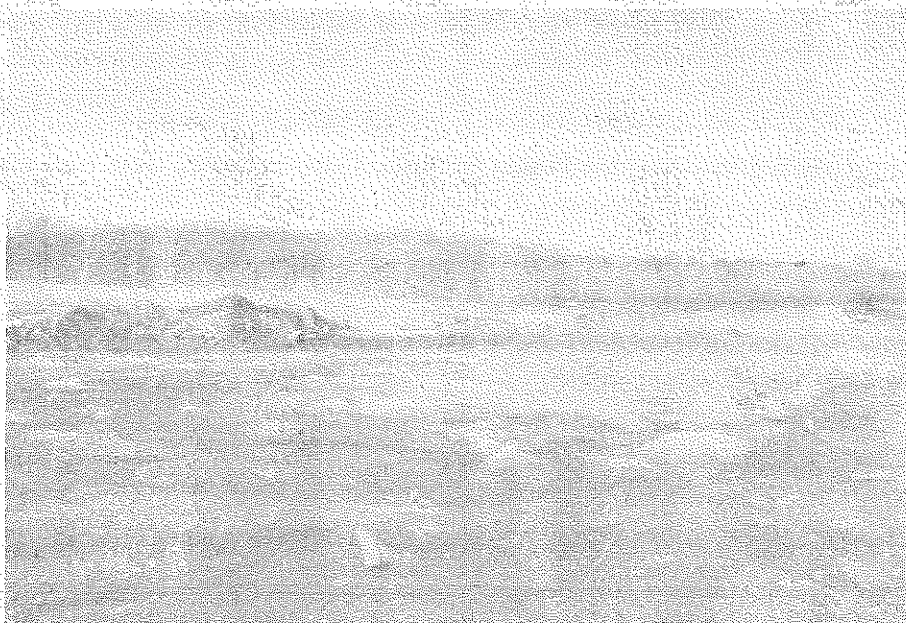
**Photo 2**

**Location and Subject:** East side of Phase 1, facing northwest – Exposed area of Phase 1 where runoff migrates to the drainage ditch north of the landfill and then to the outfall at State Road 25.

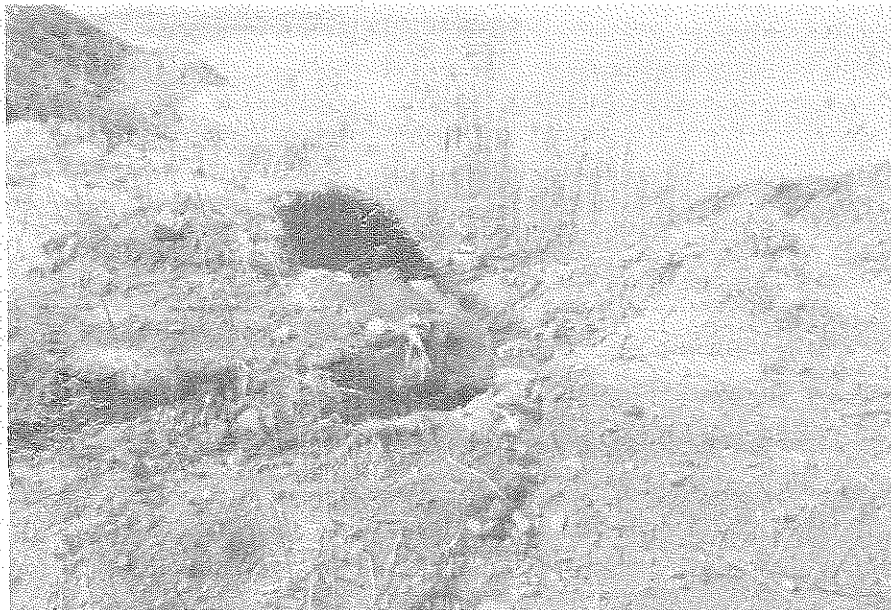
**Photo 3**

**Location and Subject:** East side of Phase 1, facing north - Erosion cut in an uncovered portion of the landfill. Runoff from this area discharges to the outfall at State Road 25 from the drainage ditch north of the landfill.

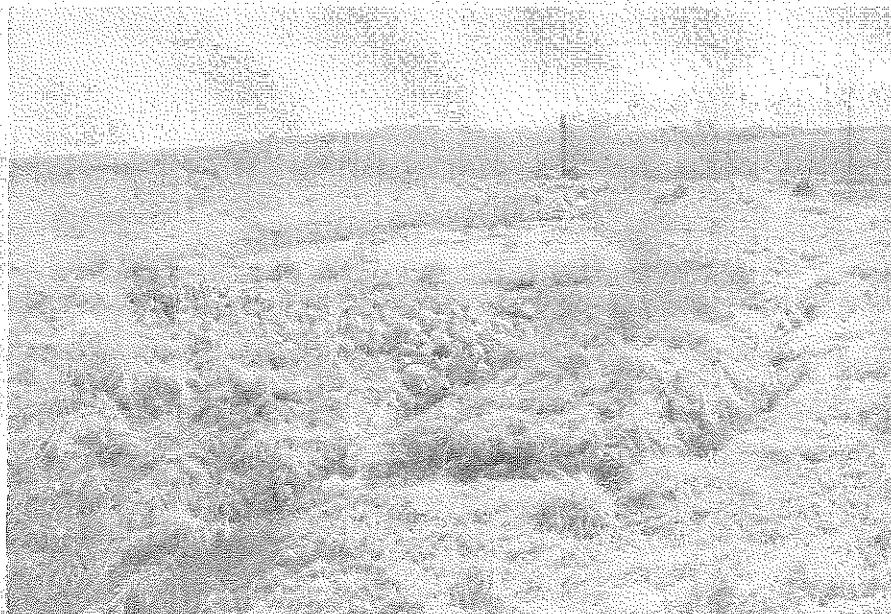
**Photo 5**

**Location and Subject:** North of Phase 1, facing south – Failure of sedimentation control device receiving runoff from the exposed portion of Phase 1.

After receipt of the Letter, Dalton repaired the check dam in Phase 3, Section 1 and constructed three additional dams so that if the flowing water manages to get past one dam, the flow will be slowed by one of the subsequent dams. The erosion that occurred this spring and early summer was worse than in most years. Northern Indiana had several torrential rainfall events where a lot of rain fell in a very short period of time. (The fact that the erosion occurred in 2008 is supported by the fact that Mr. Schafer's written quarterly inspection reports from 2007 never mention erosion as a problem). The damage caused by the erosion was repaired as soon as the weather allowed and equipment was available. In fact, most of the erosion damage has now been repaired. In addition, in the area where the erosion was the worst-- in the NE corner-- Dalton has repaired the intermediate cover so that the water will be redirected to a newly constructed swale-like area lined with rip rap that will help to prevent any further erosion in the future. Mr. Espich's contention that Dalton is now required to apply daily cover is not valid. Dalton will continue to apply intermediate cover as required pursuant to its permit until directed differently.

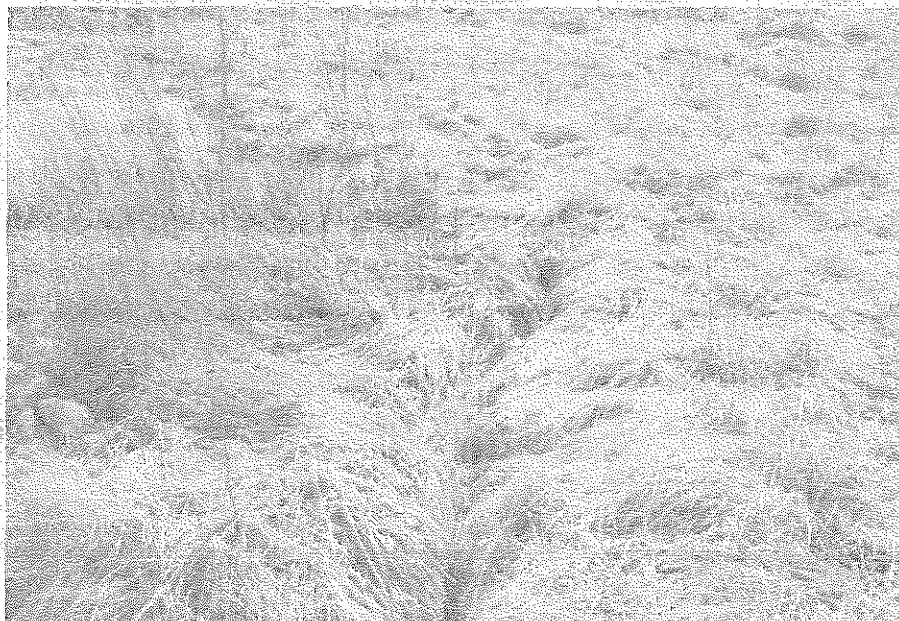
**Photo 6**

**Location and Subject:** North of Phase 1, facing south – Runoff from Phase 1 migrating around the check dam. The sedimentation control devices were not being inspected or maintained to prevent the migration of wastes off-site.

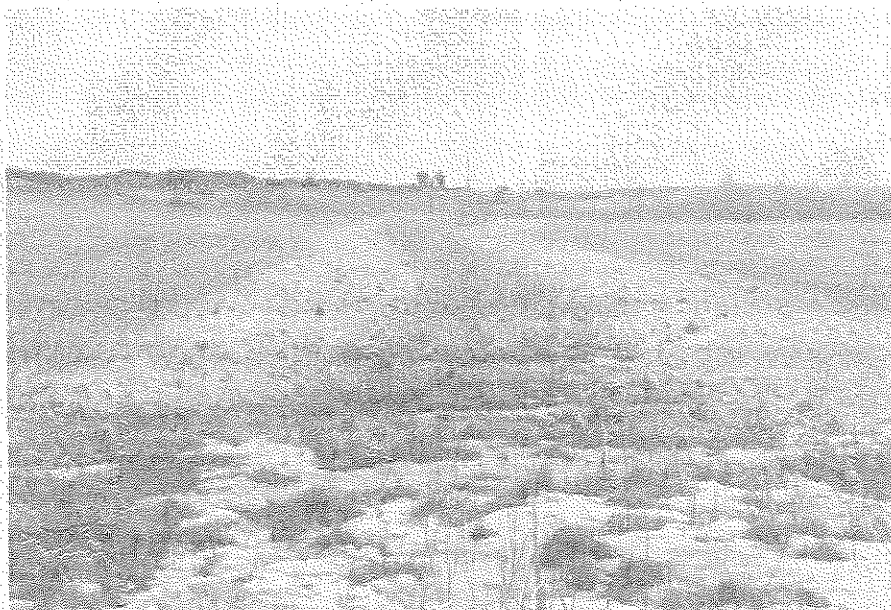
**Photo 7**

**Location and Subject:** Field north of Phase 1, facing south -- Drainage ditch receiving runoff from Phase 1 and discharging to the outfall at State Road 25.

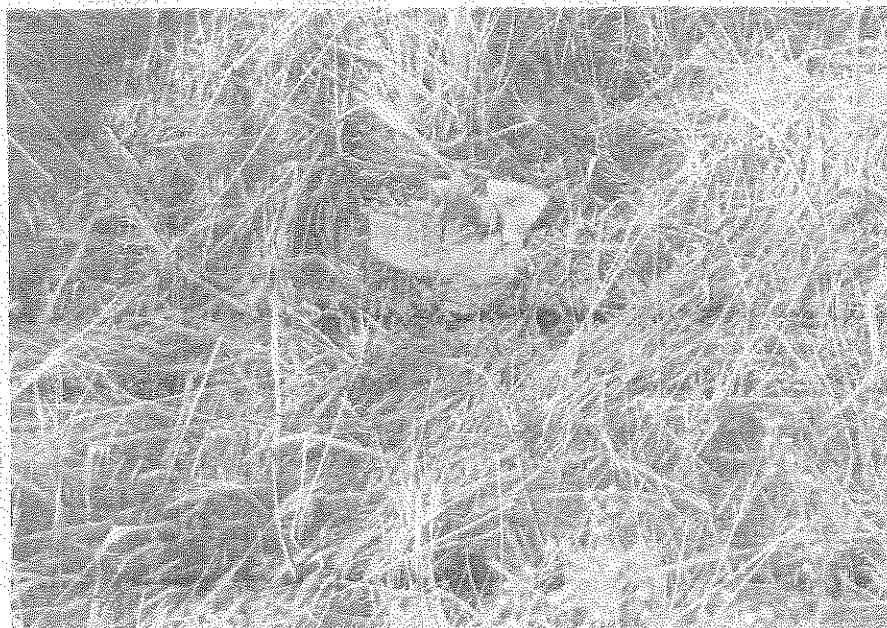
**Photo 8**

**Location and Subject:** Field north of Phase 1 -- Close up of contamination in the drainage ditch discharging to the outfall at State Road 25.

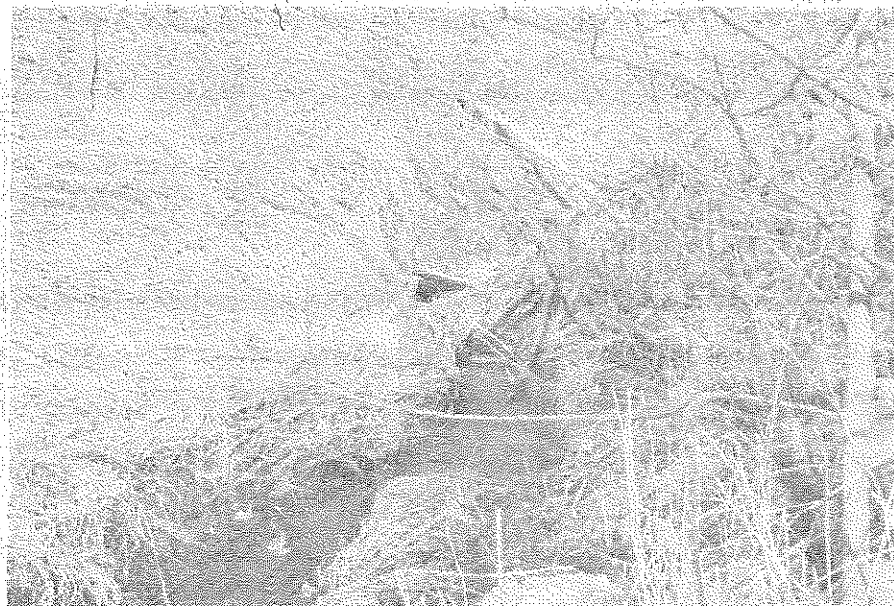
Photo 9

**Location and Subject:** Field north of Phase 1 - Outfall at State Road 25 receiving runoff from the drainage ditch north of Phase 1.

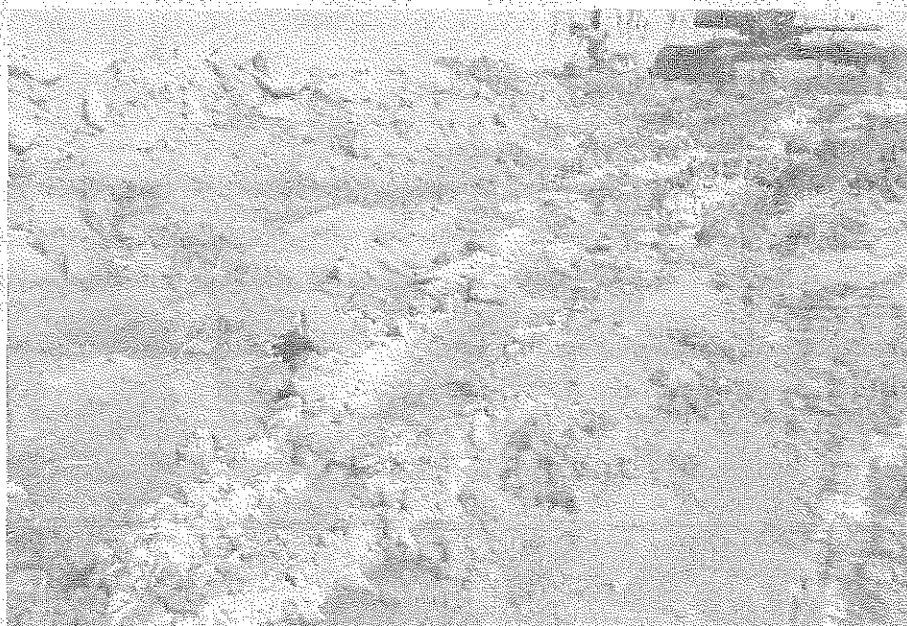
**Photo 14**

**Location and Subject:** Working face of Phase 3, Section 1, facing northeast—Water ponding on the surface of the working face and a corroded 55-gallon container of unknown material in the disposal area.

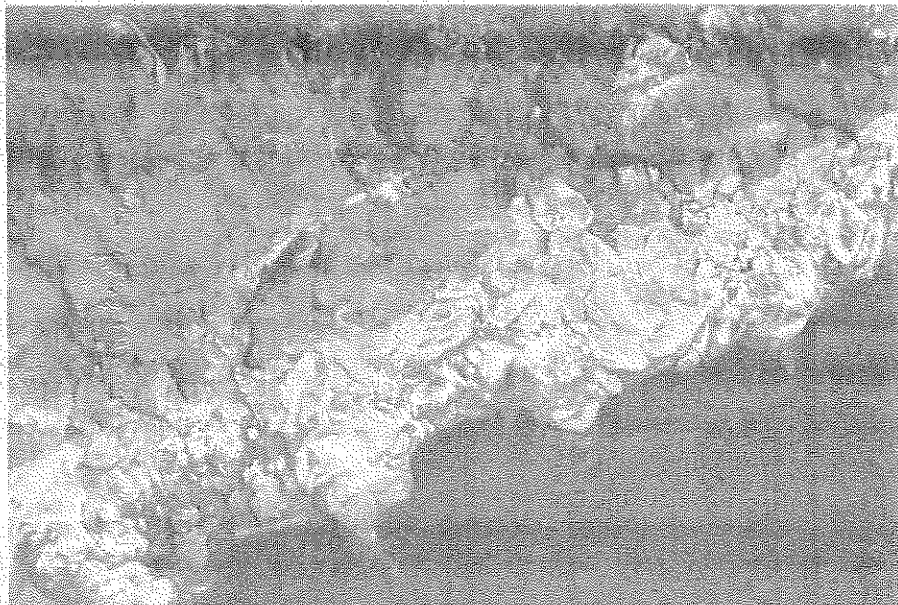
**Photo 15**

**Location and Subject:** Working face of Phase 3, Section 1 – Unknown material precipitating out of the ponded water and waste at the working face. This material was also observed at the Dalton Kendallville restricted waste site.

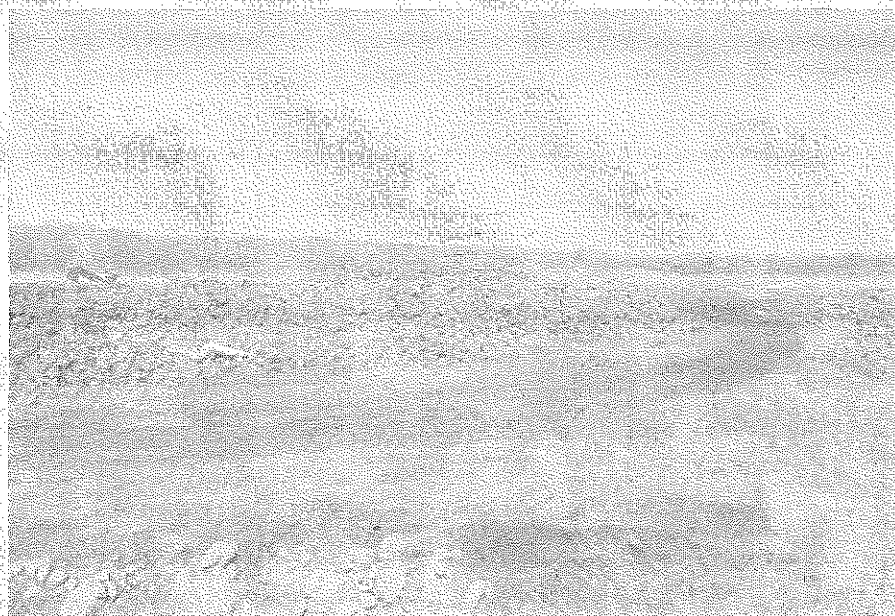
**Photo 17**

**Location and Subject:** Phase 2, facing north - Large pile of slag deposited near the border of Phase 2 and Phase 3 exceeding the height limit.

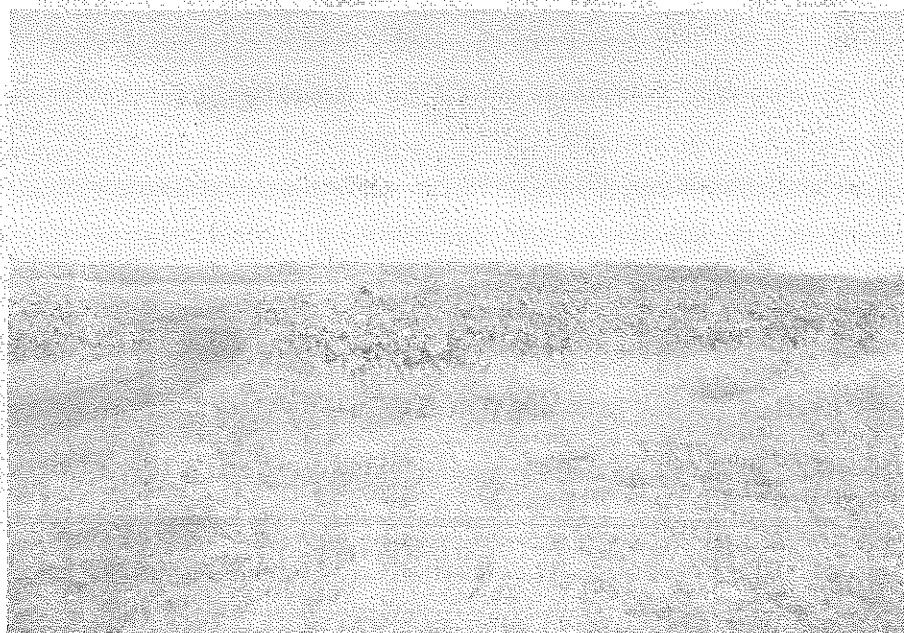
**Photo 18**

**Location and Subject:** Phase 2, facing northeast - Large pile of slag deposited near the border of Phase 2 and Phase 3. The facility's request for beneficial reuse of the slag was denied based on the waste being classified as Type II.

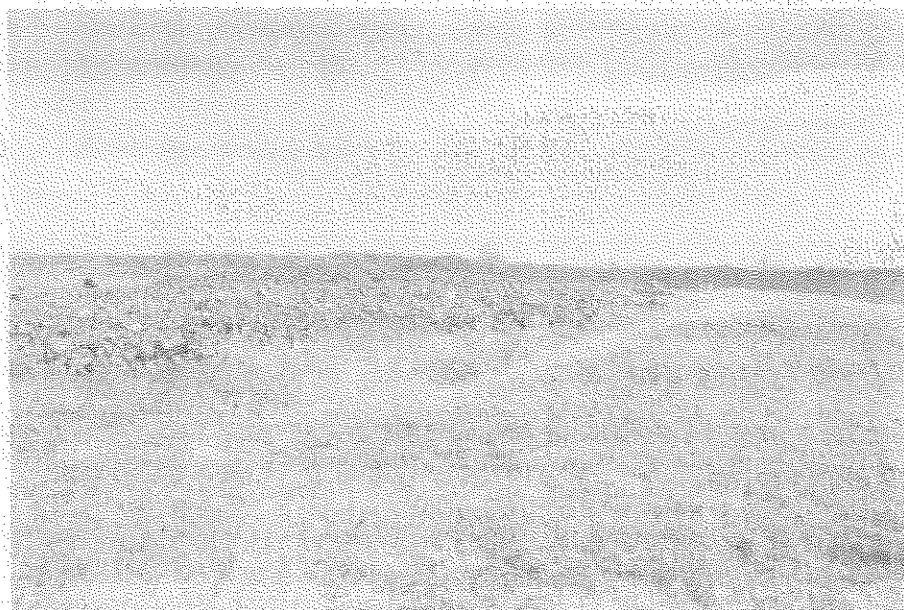
**Photo 19**

**Location and Subject:** Phase 2, facing northeast - Large pile of slag deposited near the border of Phase 2 and Phase 3. The slag pile is approximately 250 yards by 100 yards and ranging from 5 to 15 feet in height.

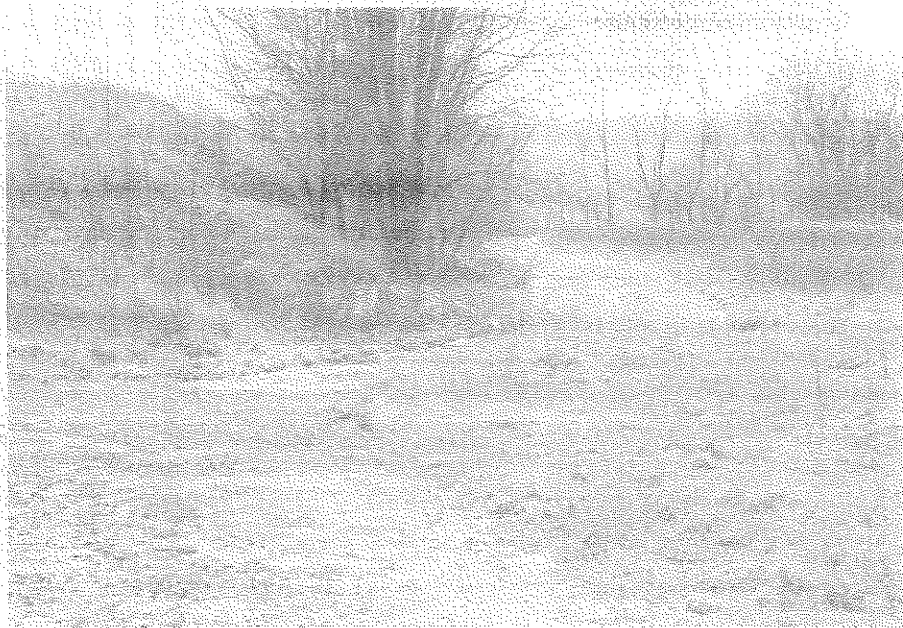
**Photo 20**

**Location and Subject:** Phase 2, facing south - Runoff from Phase 2 migrating south into a farm field.

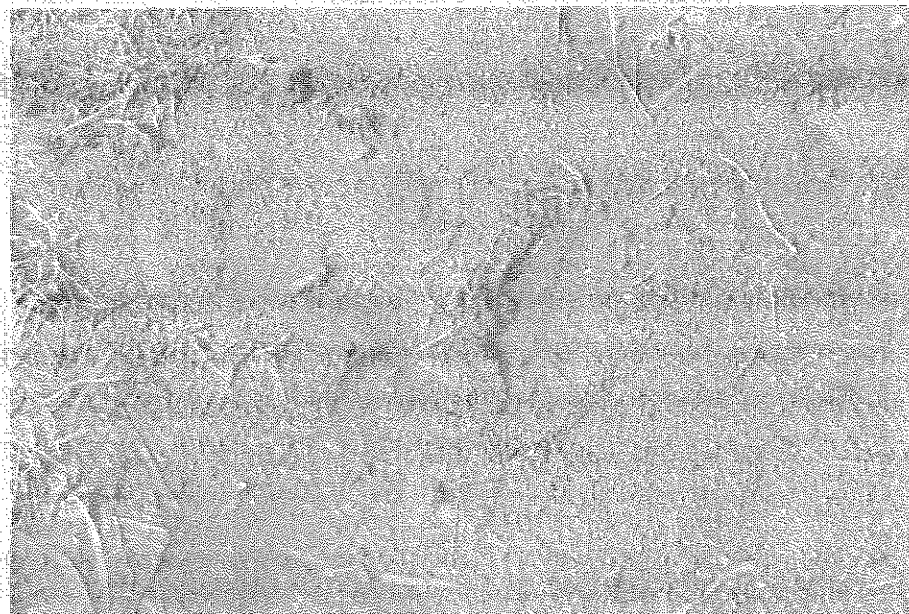
**Photo 21**

**Location and Subject:** Phase 2 – Foundry waste on the road near the southern property line.

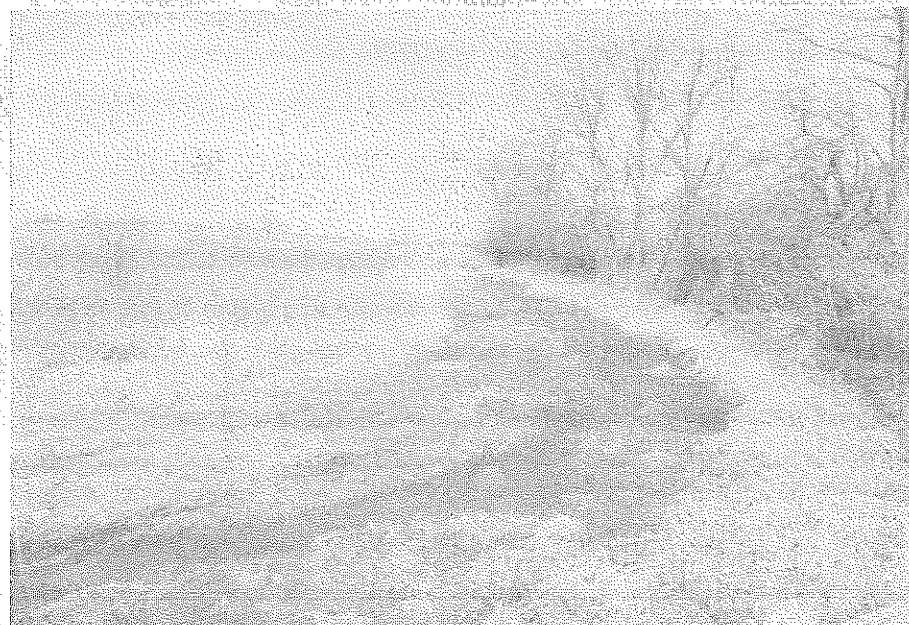
**Photo 22**

**Location and Subject:** Near the facility boundary on the south side of Phase 2, facing north – Runoff from Phase 2 migrating off-site into a farm field south of the landfill.

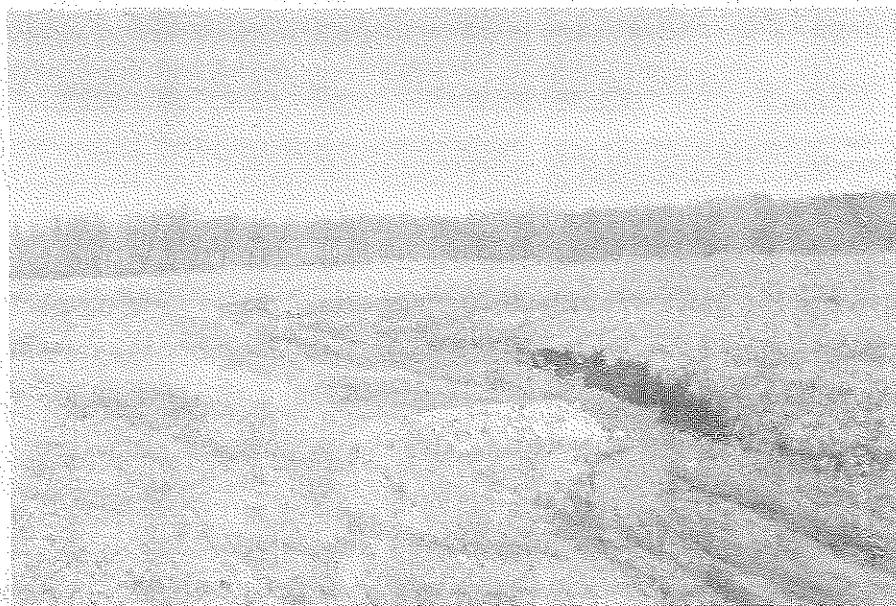
**Photo 23**

**Location and Subject:** Northeast corner of Phase 3, Section 1, facing north – Leachate discharging to the drainage ditch from the active fill area shown in photos 10-13. The sedimentation controls were not being inspected and were not maintained to prevent contamination from migrating off-site.

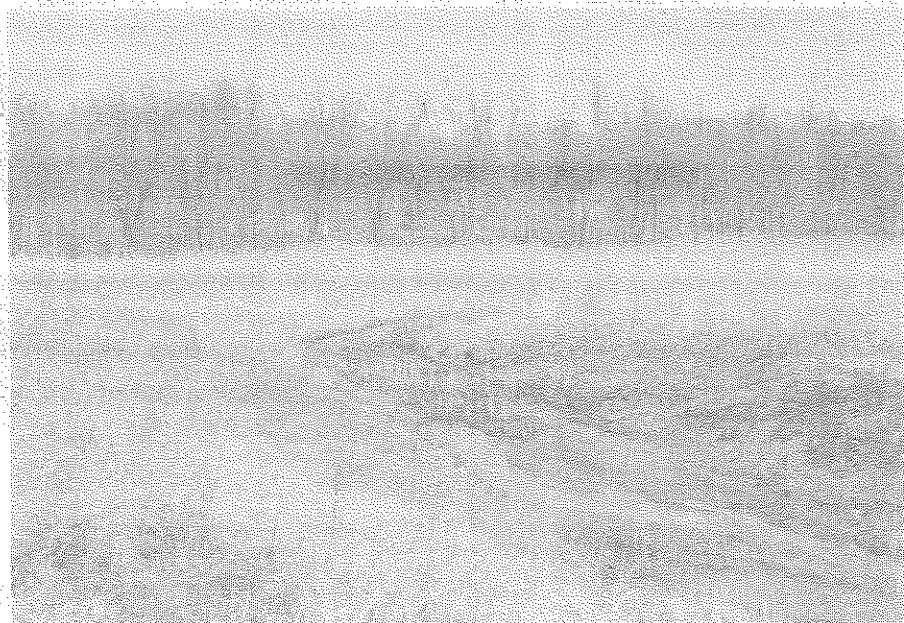
**Photo 24**

**Location and Subject:** Northeast of Phase 3, Section 1, facing north – Drainage ditch from the active fill area discharging leachate to the wetlands and into Boggs Ditch.

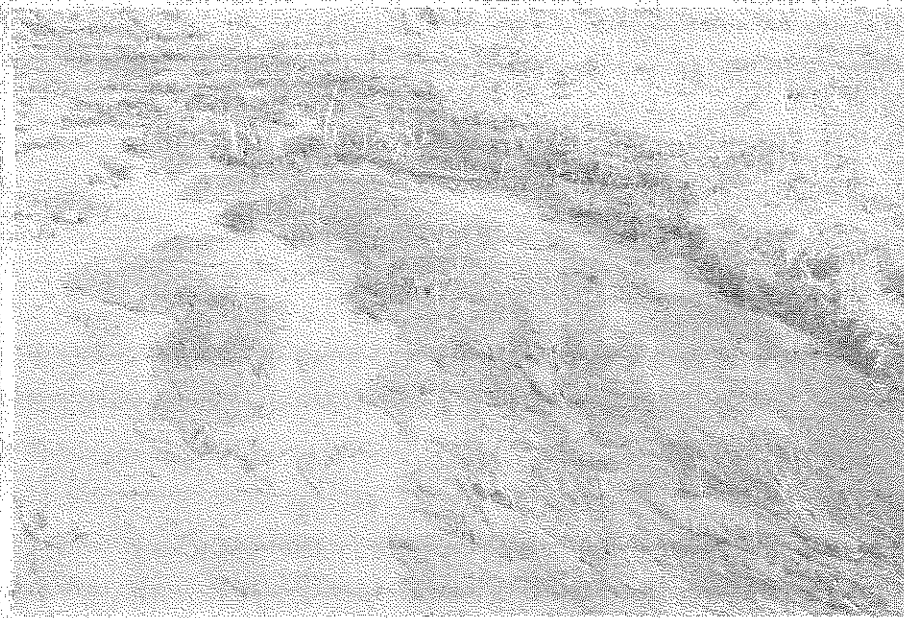
**Photo 25**

**Location and Subject:** Northeast of Phase 3, Section 1 – Drainage ditch contaminated with leachate discharging to the wetlands and into Boggs Ditch.

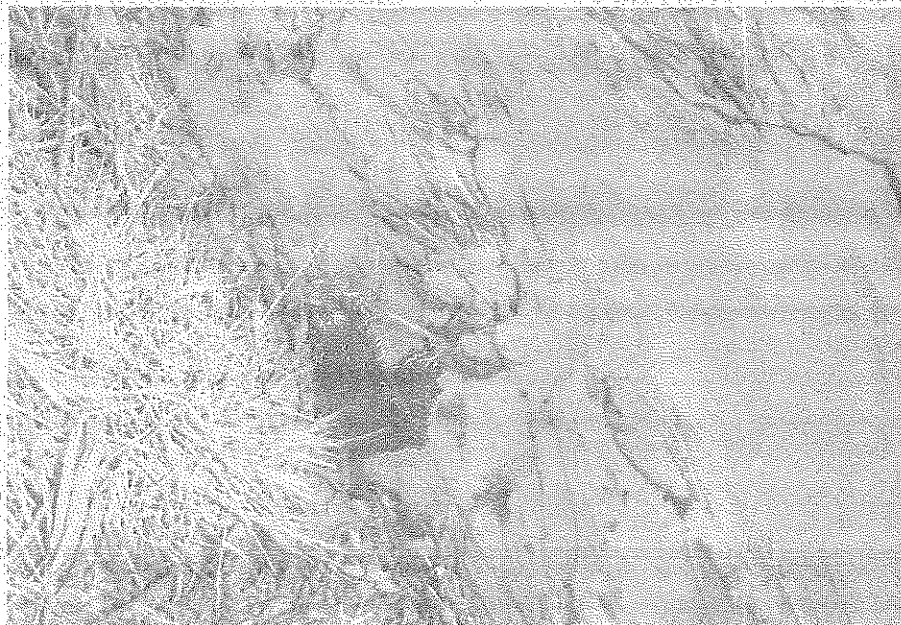
**Photo 26**

**Location and Subject:** Northeast of Phase 3, Section 1 – Drainage ditch contaminated with leachate.

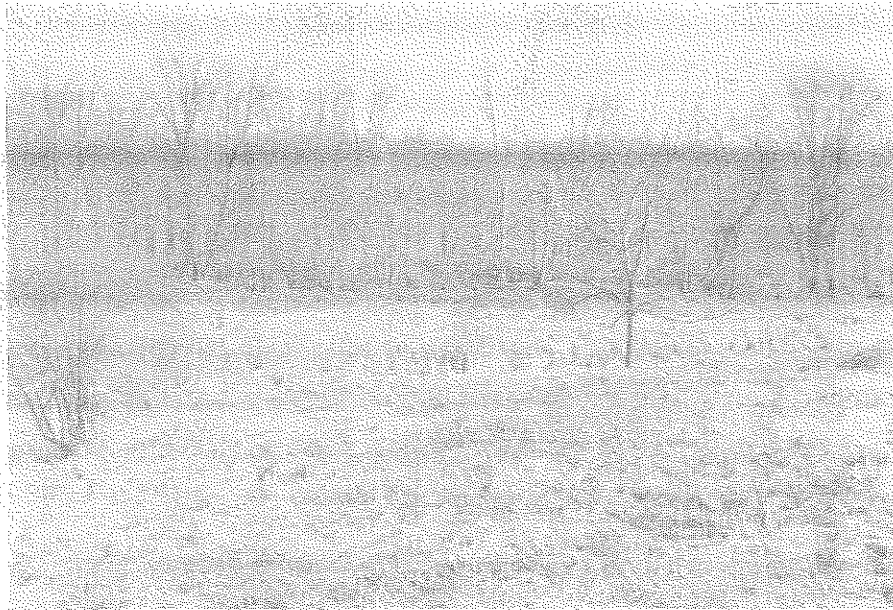
**Photo 27**

**Location and Subject:** Wetland Area and Boggs Ditch north of the landfill – Area receiving leachate from the landfill.

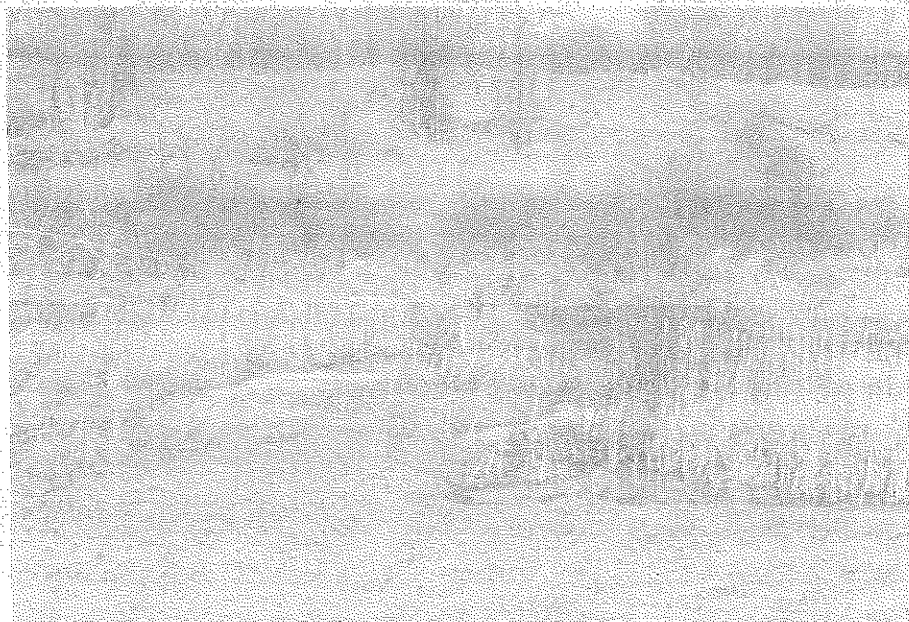
**Photo 28**

**Location and Subject:** Wetland Area and Boggs Ditch north of the landfill – Area receiving leachate from the landfill.

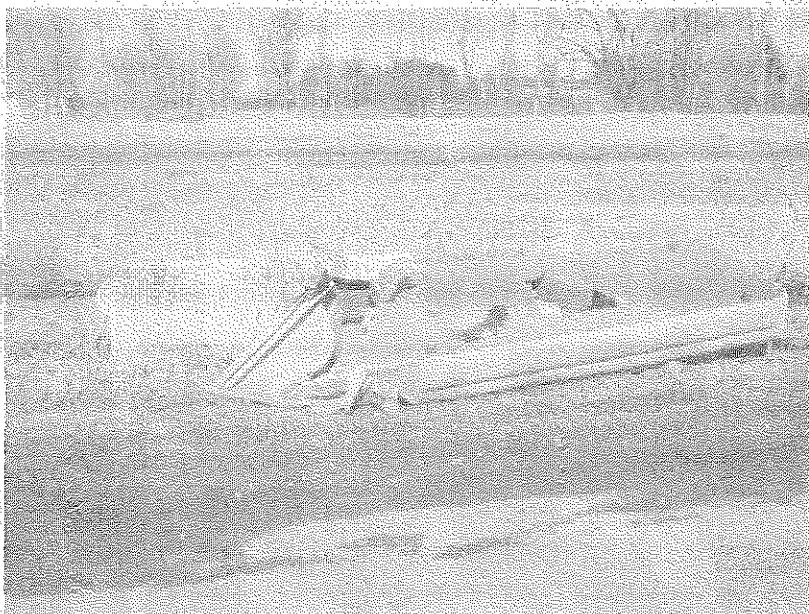
**Photo 29**

*Several pieces of furniture were observed inside the facility boundary along the north side of the road near the site entrance. The furniture was observed during the March 13, 2008, inspection and again on June 17, 2008.*

**Location and Subject:** West of the entrance, inside the facility boundary – Solid waste dumped inside the facility boundary. Access to the facility is not controlled. The gate is locked after hours.

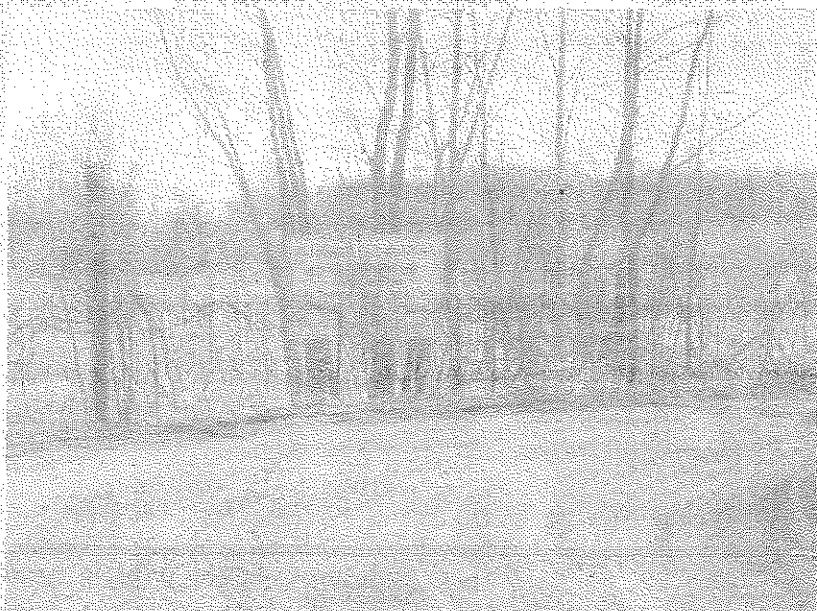
**Photo 30**

**Location and Subject:** Entrance to the facility – Gate is left unsecured during the day and locked after hours.

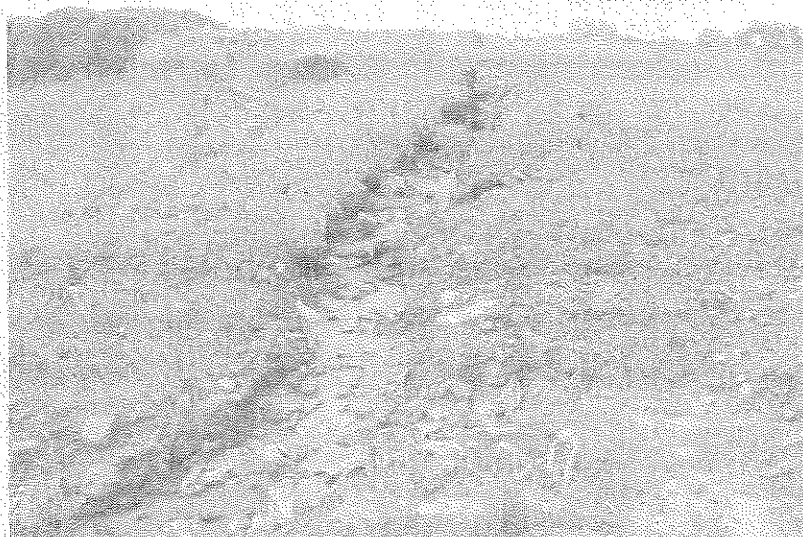
**Photo 1**

**Location and Subject:** West side of Phase 3, Section 1, facing south - Erosion of buried waste caused by surface water runoff from the top of the fill area and migrating into the bottom of the fill area.

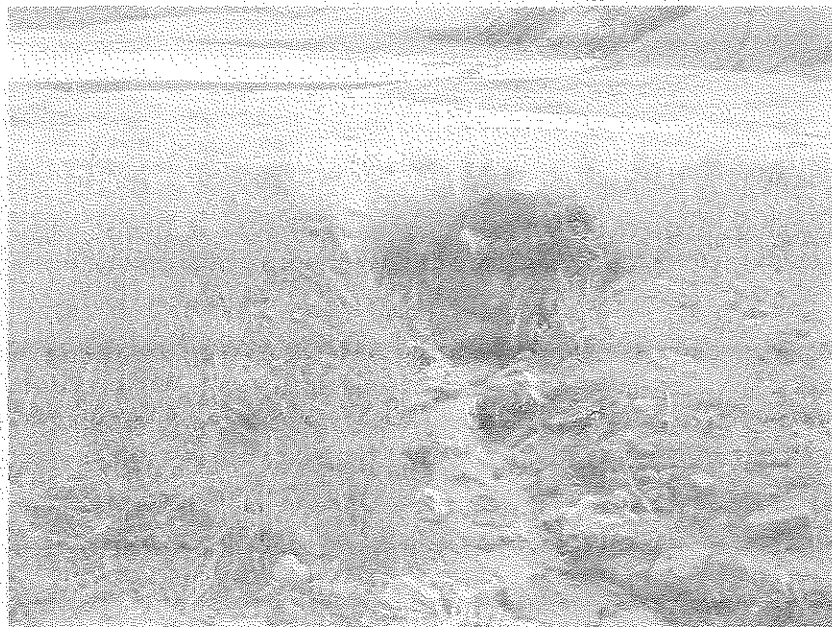
**Photo 2**

**Location and Subject:** West side of Phase 3, Section 1, facing east - Erosion of buried waste caused by surface water runoff from the top of the fill area and migrating into the bottom of the fill area.

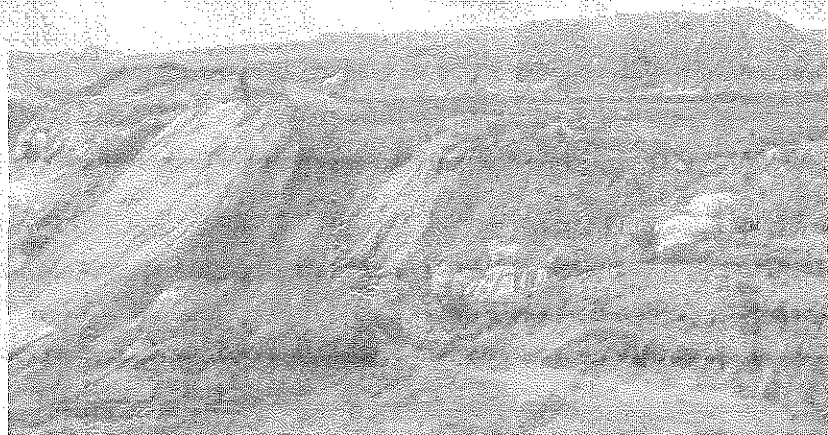
**Photo 8**

**Location and Subject:** West side of Phase 3, Section 1, facing east - Working face of the fill area with ungraded piles and visible signs of erosion caused by surface water.

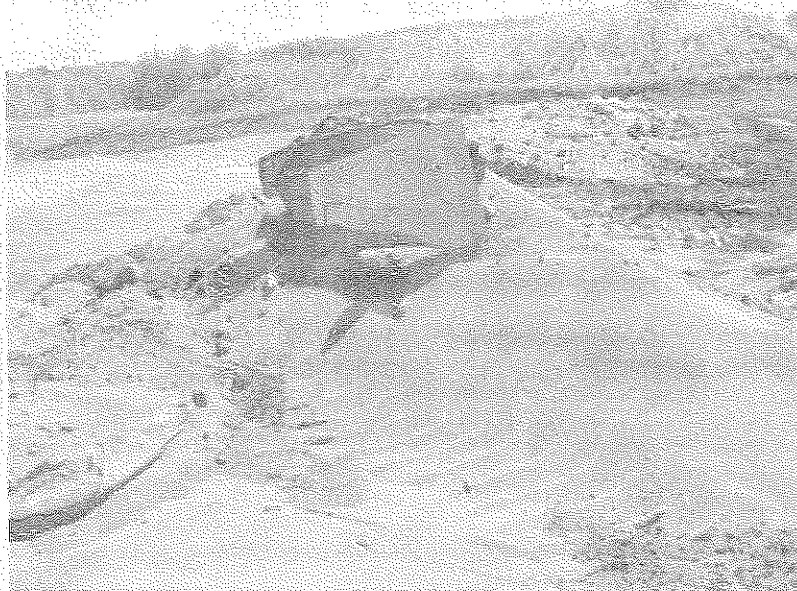
**Photo 9**

**Location and Subject:** South side of Phase 3, Section 1, facing northeast -- Open dumping of solid waste at the working face.

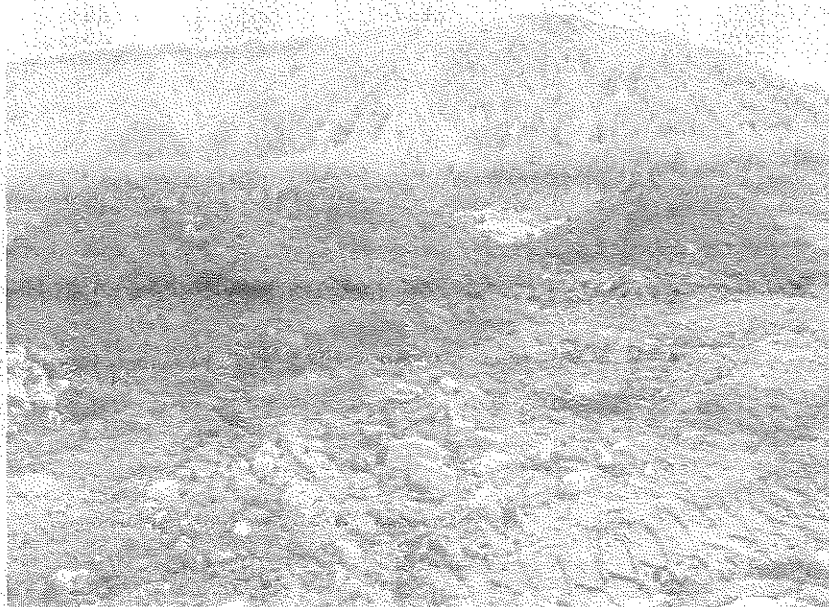
**Photo 10**

**Location and Subject:** South side of Phase 3, Section 1, facing east -- Piles of yard clean up.

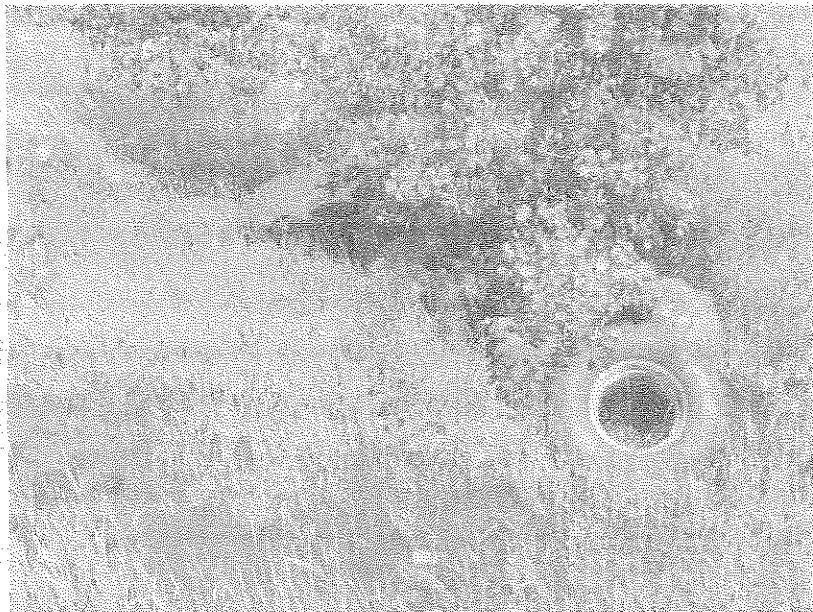
**Photo 17**

**Location and Subject:** East side of Phase 1 - Open dumping of waste tires and plastic piping in the landfill. These wastes were also observed during the March 13, 2008, inspection.

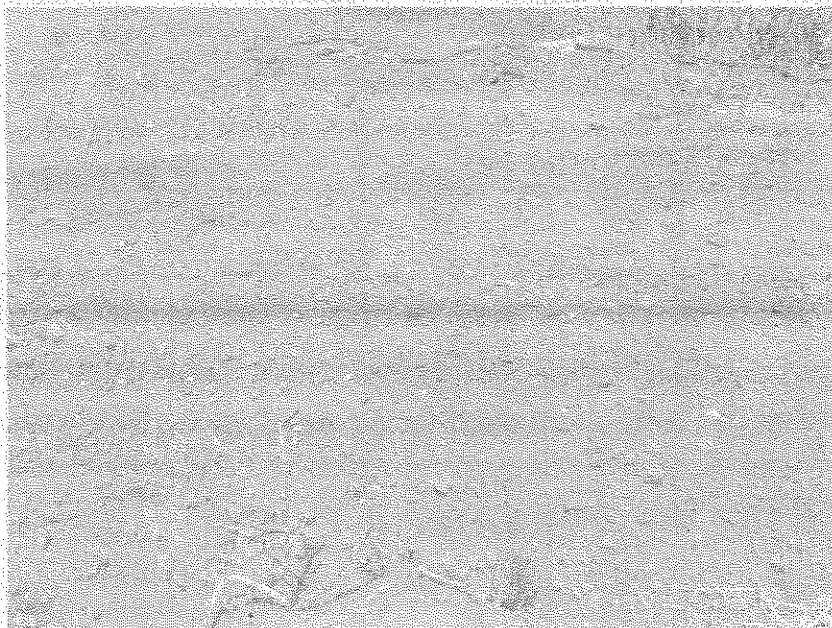
**Photo 18**

**Location and Subject:** East side of Phase 1 - Disposal of grinder dust that is a Type I waste prohibited from disposal at this site.

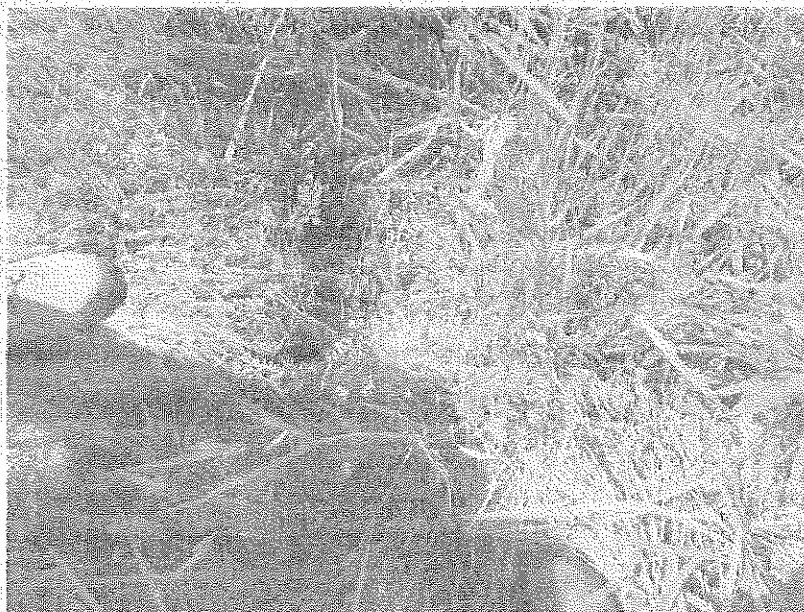
**Photo 19**

**Location and Subject:** Phase 1 - Erosion in the intermediate cover near monitoring well 10.

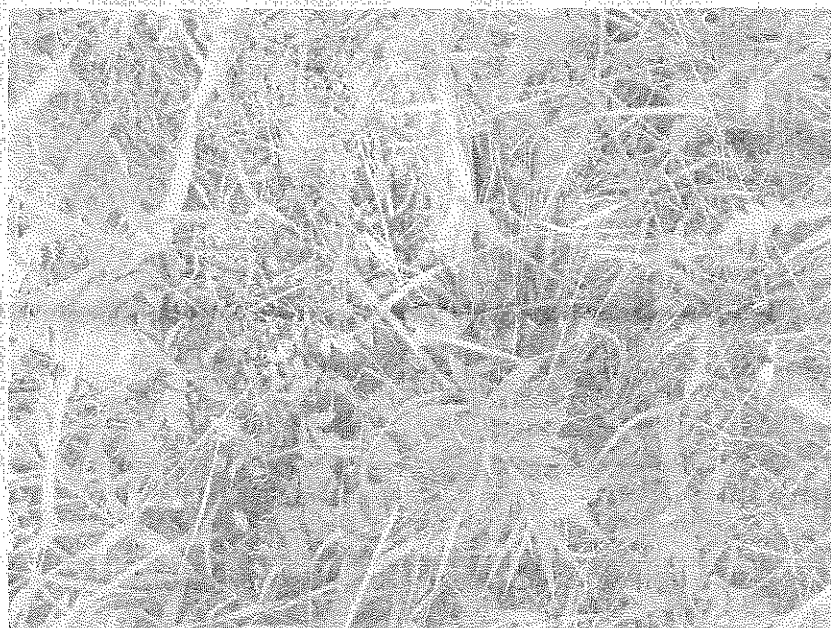
**Photo 20**

**Location and Subject:** South side of Phase 2 - Erosion, ponding water, and exposed waste along the southern boundary.

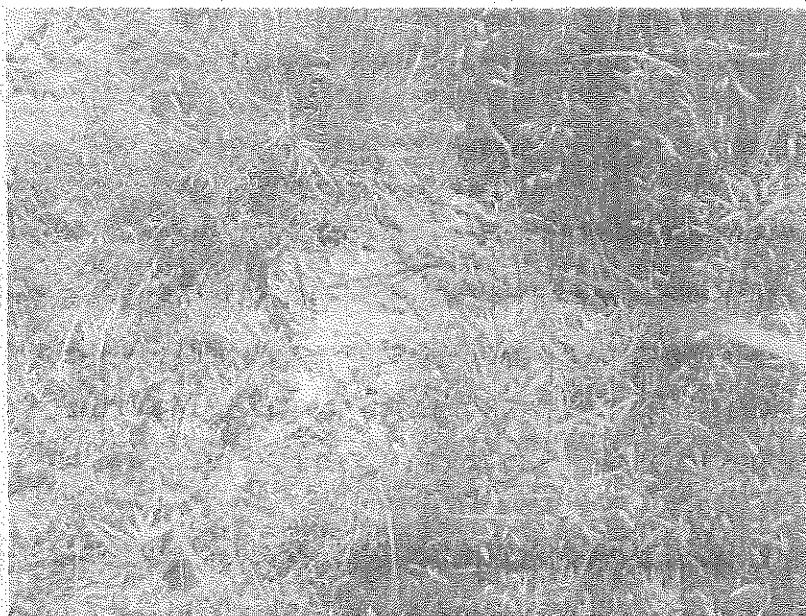
**Photo 21**

**Location and Subject:** South side of Phase 2 – Exposed waste along the southern boundary.

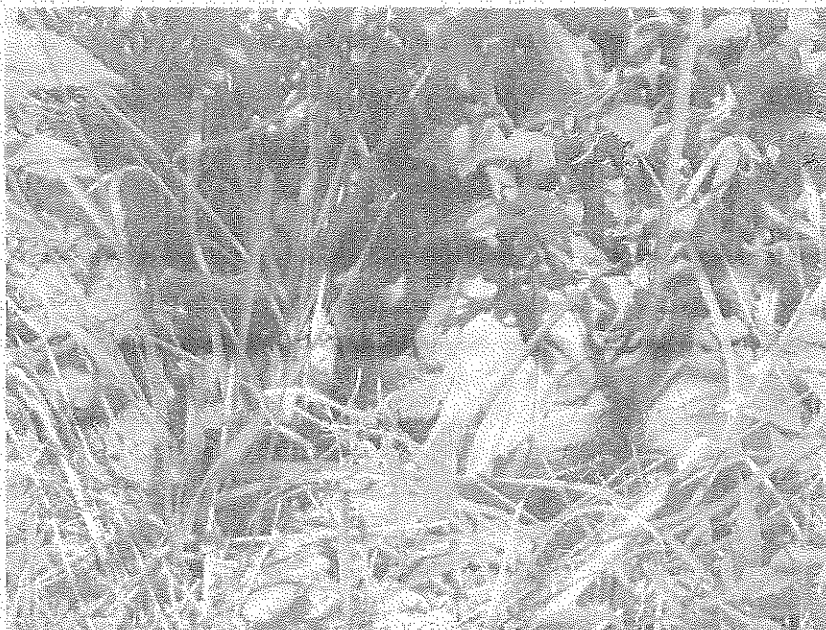
**Photo 22**

**Location and Subject:** South side of Phase 2 – Exposed waste along the southern boundary.

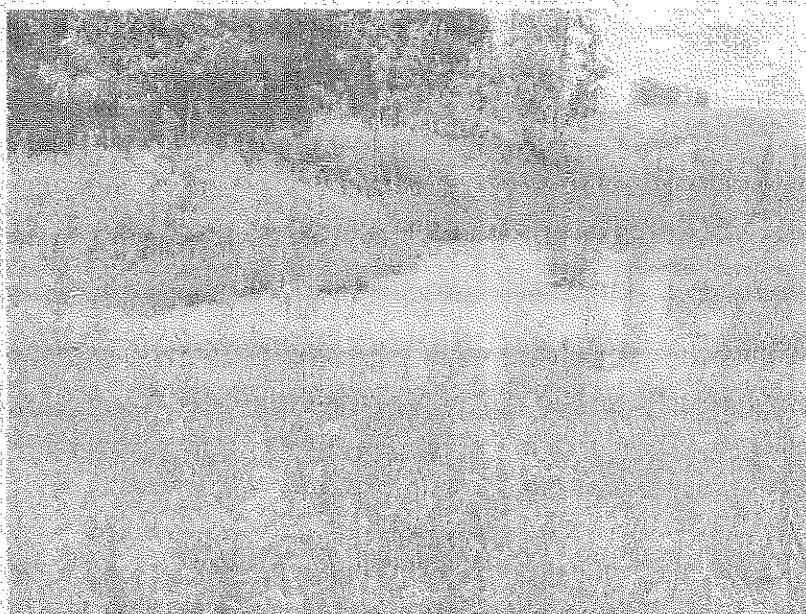
**Photo 23**

**Location and Subject:** South side of Phase 2 - Ponding water and large trees on the disposal area along the southern boundary.

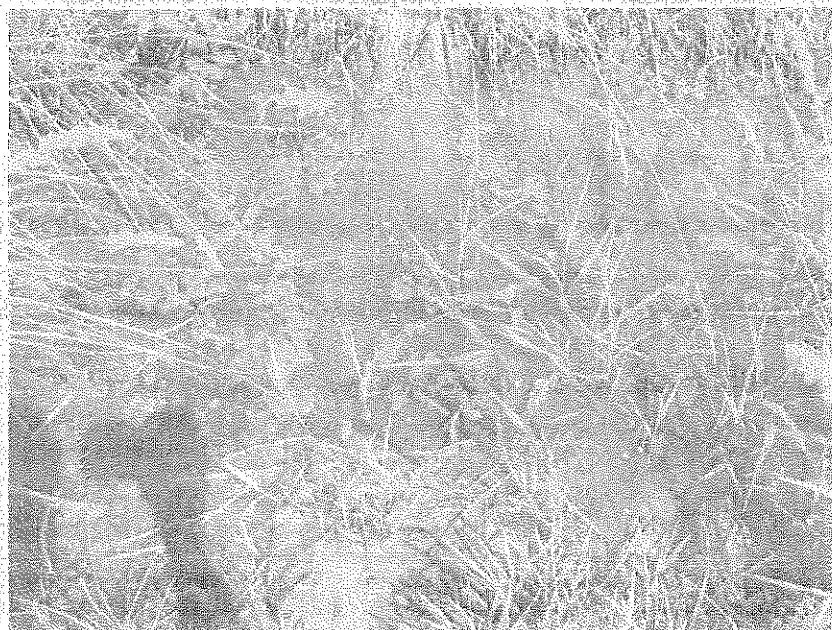
**Photo 24**

**Location and Subject:** South side of Phase 2 - Leachate on the surface of the disposal area along the southern boundary.

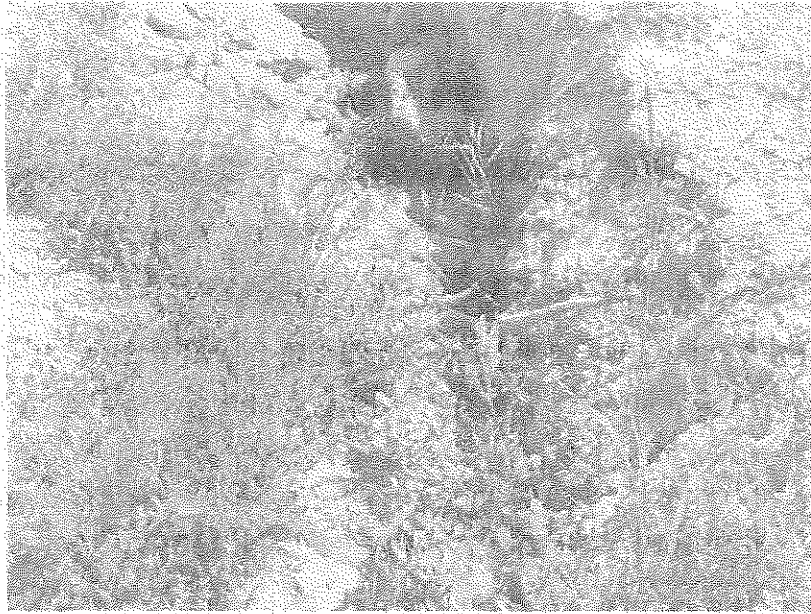
**Photo 25**

**Location and Subject:** East side of Phase 2 – Erosion cut through the cap exposing the buried waste.

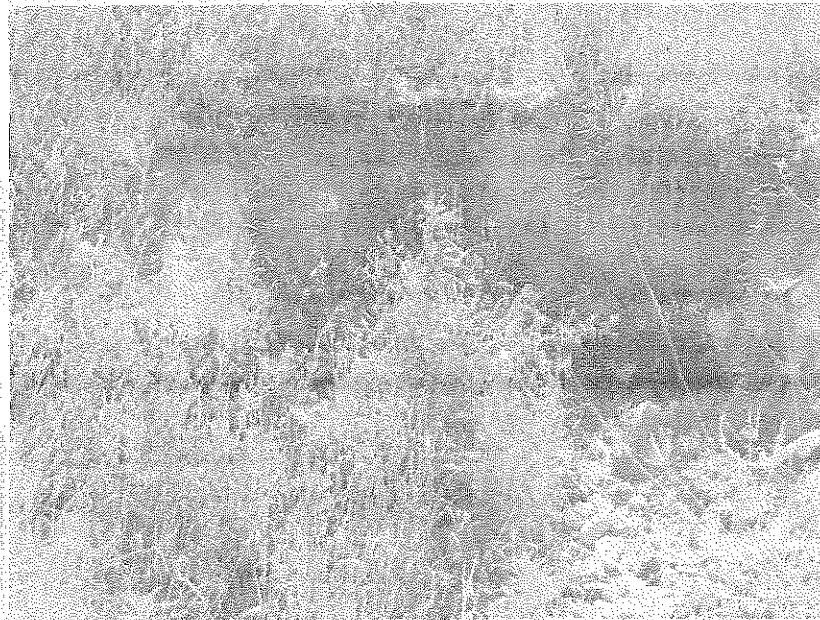
**Photo 28**

**Location and Subject:** Northeast side of Phase 2 - Large erosion cut through the cap, buried waste, and into the bottom clay liner.
